In-stream Remediation of a Hydrocarbon Release in North Central Alberta, Canada

Wayne Wiebe, A.Sc.T., CCEP
General Manager

May 2-4, 2006

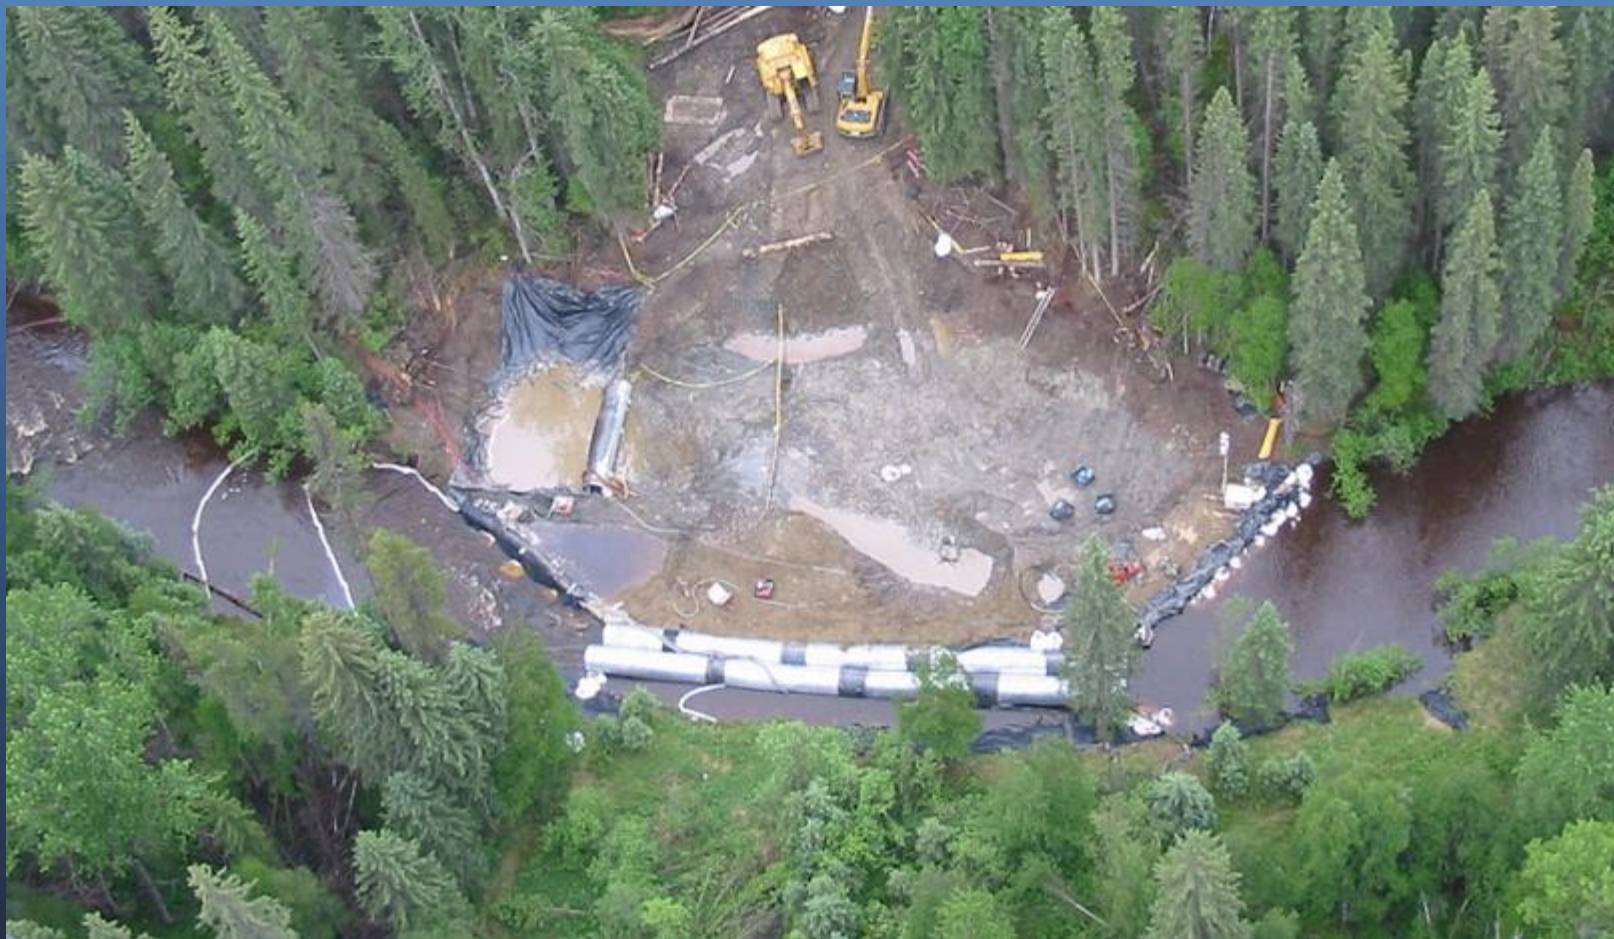
Overview of breakpoint (initial stream diversion in place)

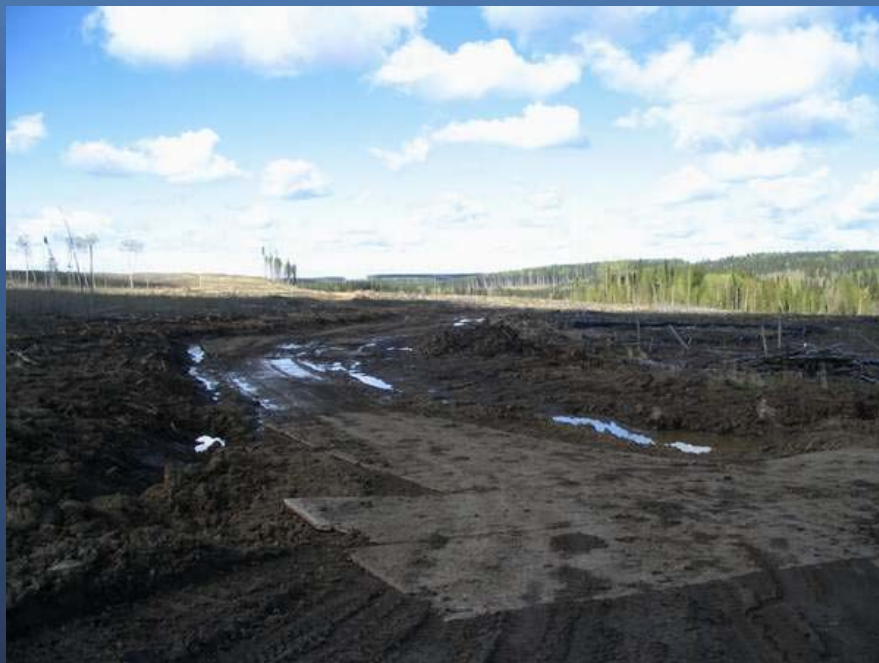
Road was constructed using 'swamp mats' and was approximately 0.6 miles long

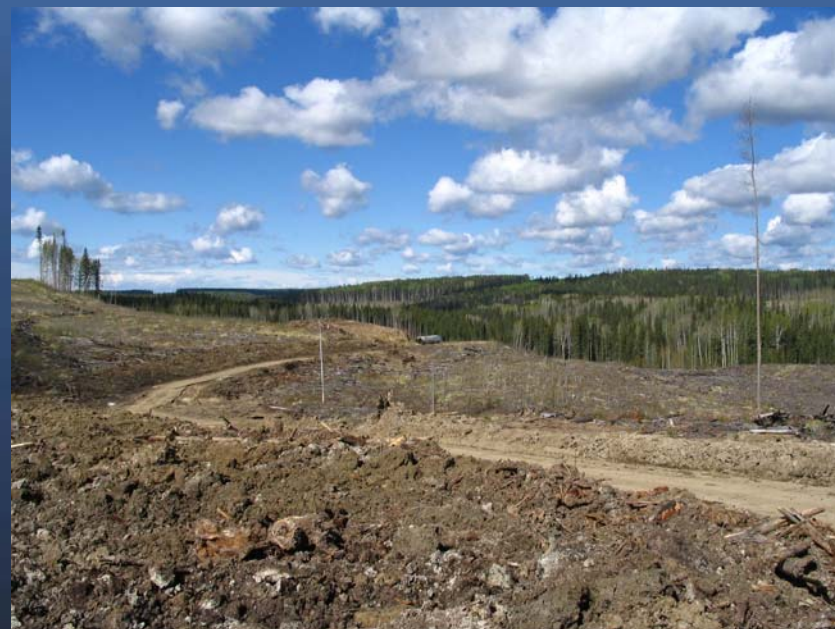
Followed general direction of a previously reclaimed forestry road

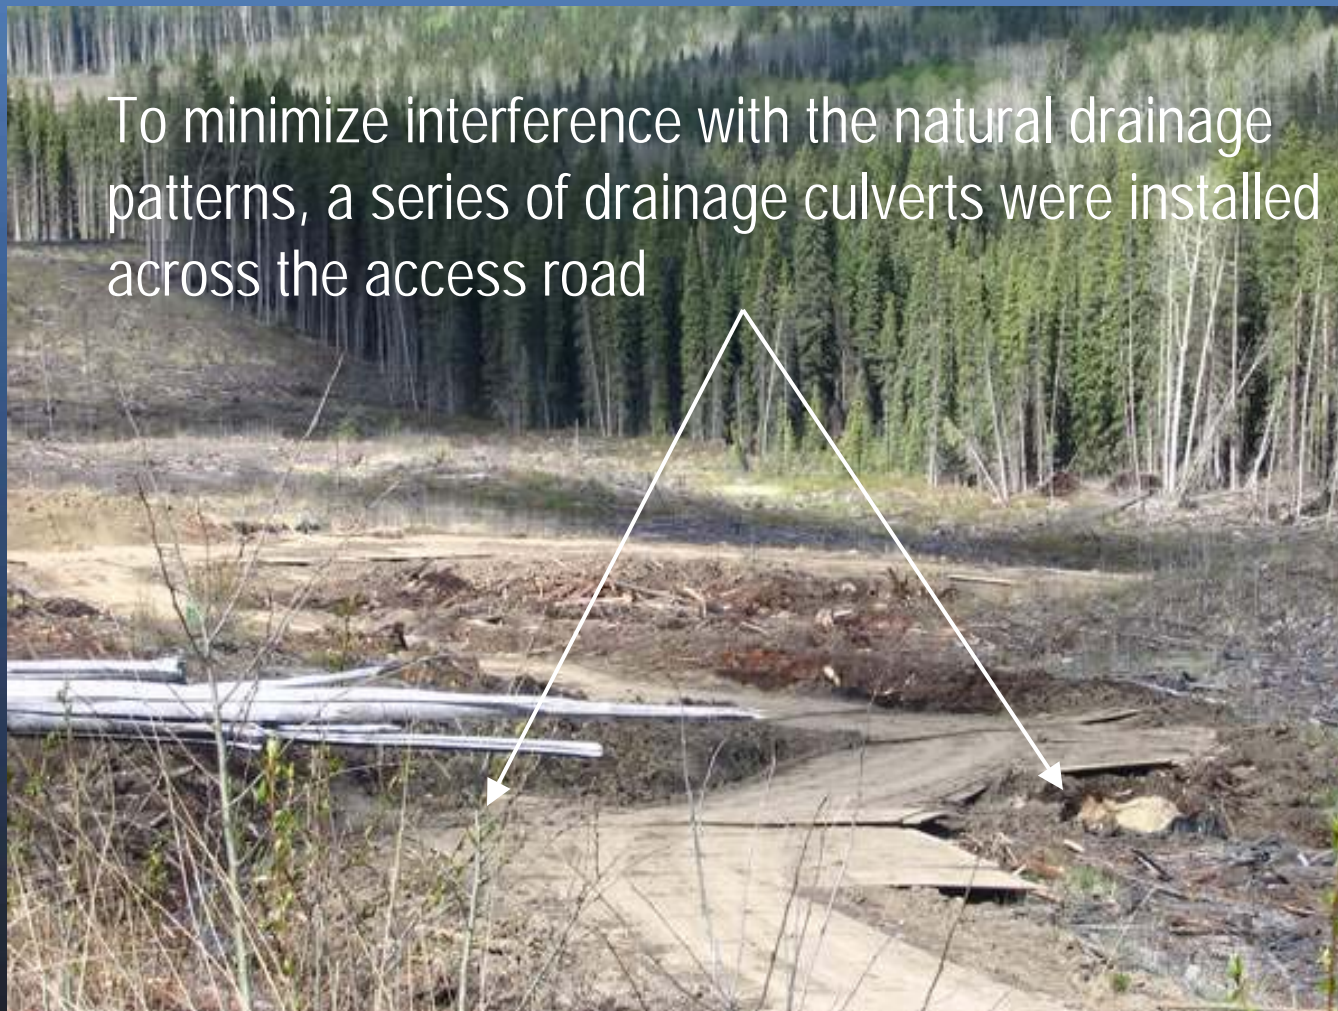
Erosion control blankets (ECB) and silt fences were installed at the discharge of the drainage culverts

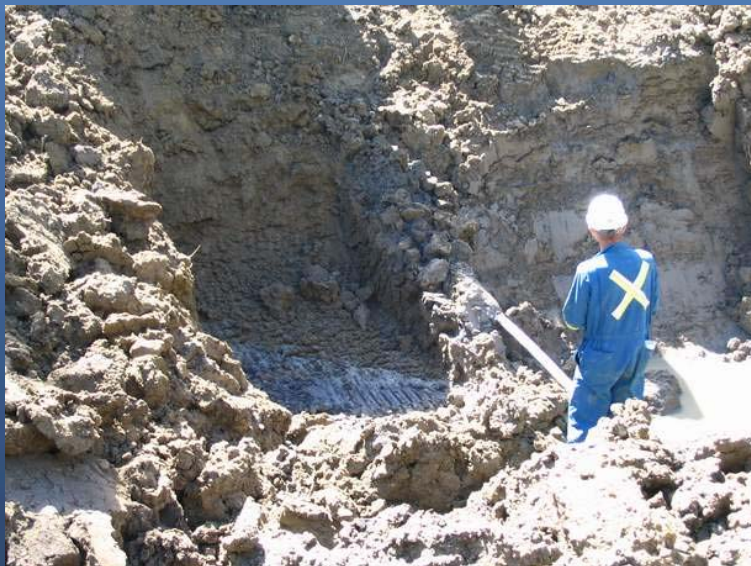
Initial pipeline exposure

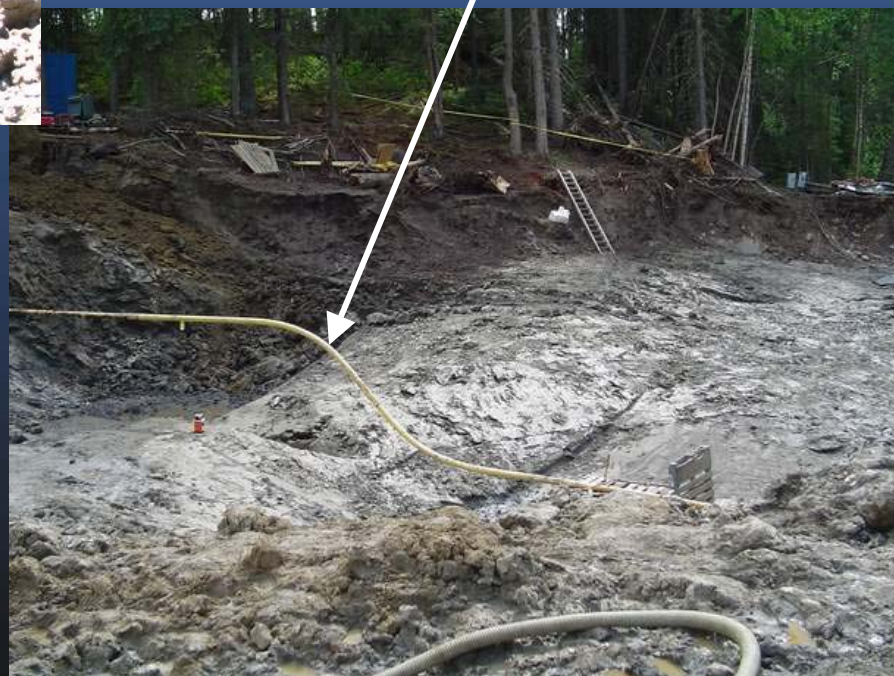
Exposed pipeline
